# Manhole Inspection Summary

Manhole # S39G\_\_054MH

Insp Date: **7/14/08 1:53 PM**

**Location** Address: **18 S High St**

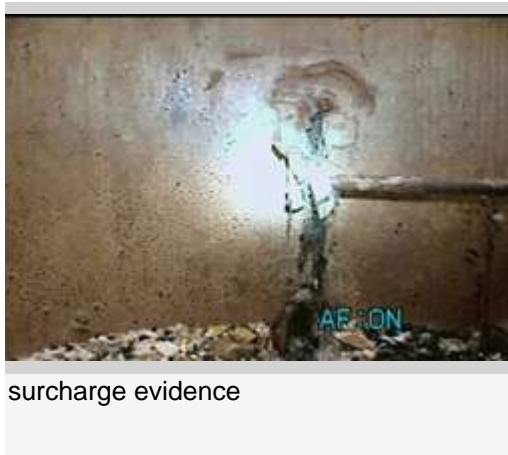
Defect 4

**Surcharge** ☒ **Evidence Of Surcharge** Depth: **9.** (ft.) ☐ Active Surcharge Present

surcharge evidence

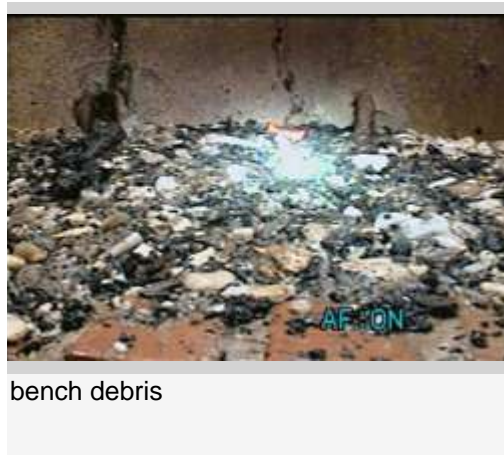
Defect 3

Condition: ☐ Sound ☐ Cracked ☐ Root Intrusion ☐ Deteriorated ☐ Leaks ☒ **Debris**

bench debris

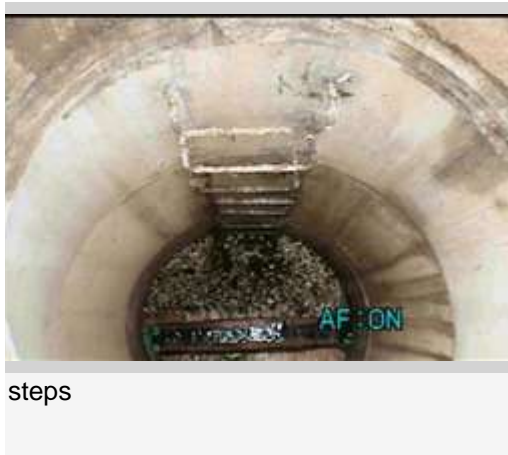
Defect 2

**Steps** Count: **8** Missing: **0** ☒ **Corroded**

steps

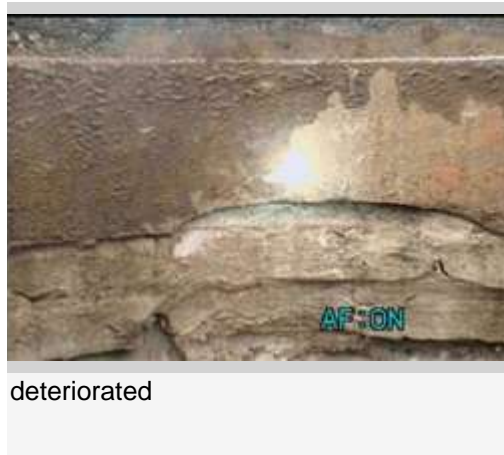
Defect 1

Condition: ☐ Sound ☐ Cracked ☐ Root Intrusion ☐ Loose Brick ☒ **Deteriorated**

deteriorated

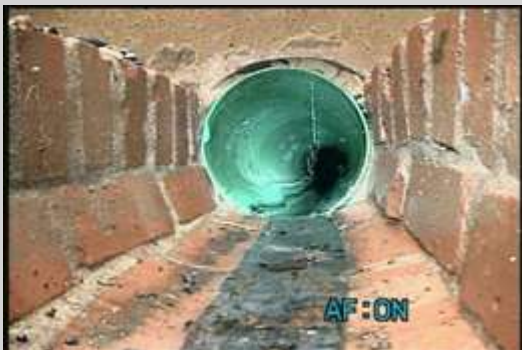
12 O'Clock Outflow

8 in. Circular Gravity Sewer  
Pipe Out @ 12 O'Clock

Invert Depth: **10.38** (ft.) Flow Characteristics: **Slow**

Infiltration: **None** Pipe Seal Cond: **Unknown**

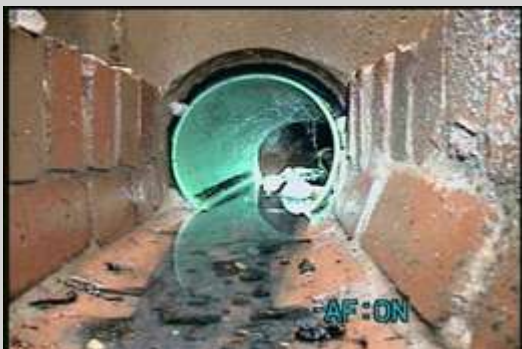
6 O'Clock Inflow

8 in. Circular Gravity Sewer  
Pipe In @ 6 O'Clock

Invert Depth: **10.20** (ft.) Flow Characteristics: **Slow**

Infiltration: **None** Pipe Seal Cond: **Unknown**
